Refrigerant Troubleshooting

Where are most freon leaks located?

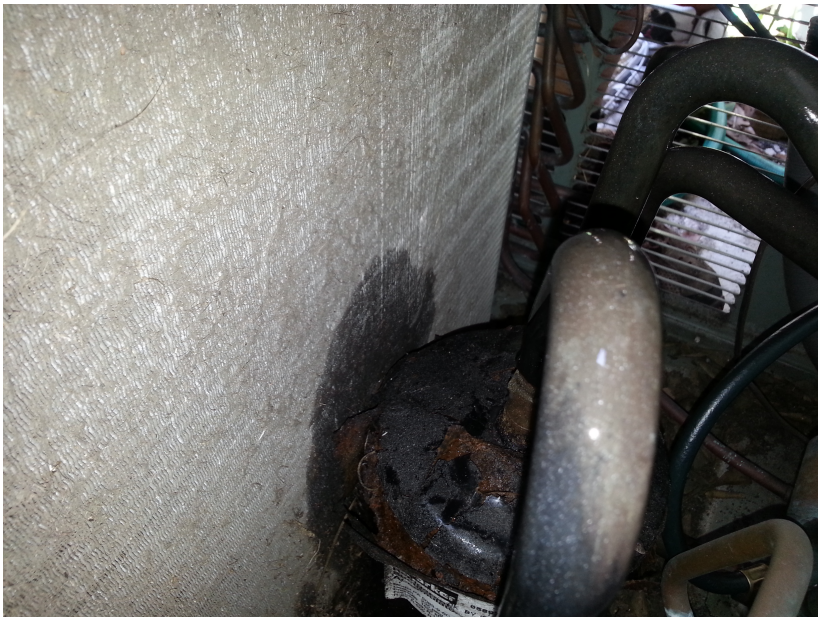
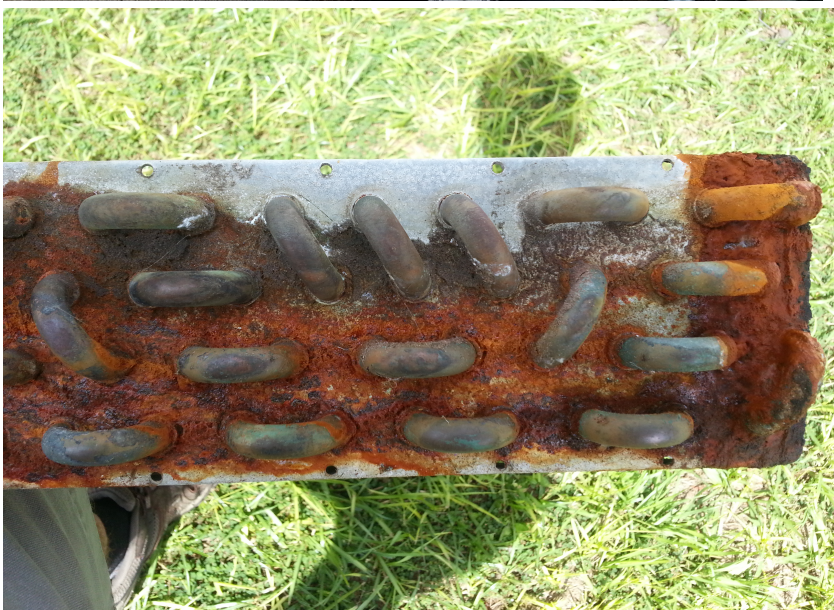
Most freon leaks occur in the evaporator coil inside the air handler. This is due to rust on the header plate of the evaporator coil. The rust punctures the copper lines on the coil. Leaks can happen about anywhere else in the system due to vibrations and rubbing. There are other parts that do rust out and cause leaks including dryers, accumulators and compressors. These components do not develop leaks as frequently as the evaporator coil. Very rarely do leaks occur in the line set itself in between the condenser and air handler.
